EXECUTIVE SUMMARY

WINDHAM SOUTHEAST SUPERVISORY UNION

INVESTMENT GRADE ENERGY AUDIT

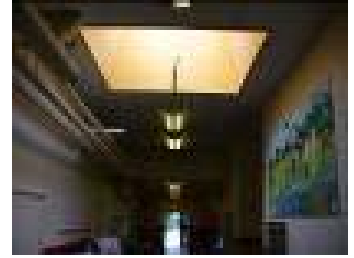
ECM # AES 1 Lighting Upgrades

Additional sensors mounted either on the wall or on the ceiling will curtail the energy usage of many offices, restrooms and classrooms. In the hallways where skylights provide free natural daylight, photo sensors will be installed to dim the artificial lights based upon the amount of sun light entering the space. Both occupancy and photo sensors serve to reduce energy consumption and maintenance efforts. Vendmisers will also be installed on all vending machines located within the school to save additional energy.

Electric kWh Saved	Electric Dollars Saved	Maintenance Savings	Capital Cost Avoidance \$	Total Savings \$	Installed Costs \$	Simple Payback Years
66,742	\$8,810	\$1,132	N/A	\$9,942	\$139,916	14.1

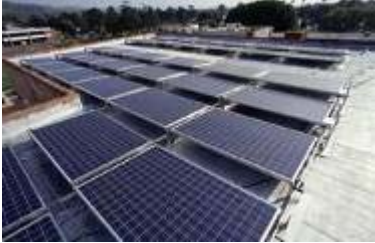
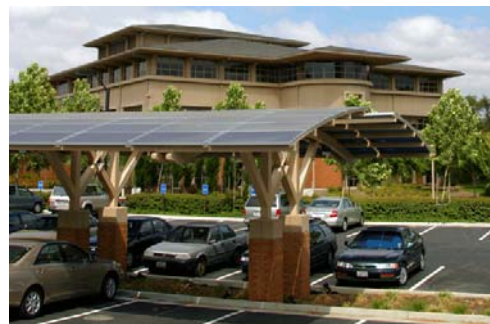
1. Solar Energy

Through this efficiency project, Brattleboro is reducing energy consumption. Now is the best time to introduce a solar electric (photovoltaic [PV]) system. The electricity produced by a PV system is used on-site resulting in reduced electricity demand from the utility. This provides valuable cost savings, especially during peak daytime periods, which is when solar systems produce the most electricity. Many of Brattleboro's accounts are currently on time of day (peak/off-peak) pricing. The more expensive peak hours will see the reduction, adding to the overall savings. Additionally, energy prices are volatile and will rise over the long-term. As rates rise, a PV system provides increased savings. Furthermore, Federal government incentives are available through rebates and incentives and can cover much of the cost of a solar electric system.

If implementing a PV system, Brattleboro would also be able to utilize monitoring equipment, both on-site and through a website, to illustrate and promote the clean renewable power being generated. Also, when Brattleboro is using less electricity than is being created at that moment, the system could charge batteries and provide backup power, or potentially sell power back to the grid through net-metering.

A feasibility study of adding a PV system to one or more school or municipal building roofs, or as a car shading structure, can be performed by American Energy Care with interest from Honeywell and Brattleboro.
